TORO 80-0059

TORO 9-2770

DESCRIPTION

These models are reduced pressure assemblies. They were produced from approximately 1969-1977. It was redesigned and replaced by the Toro Model BRP. Note there is a different model number for each size. This model uses a vertical piping configuration where water goes in the bottom and comes back down out of the bottom. The body was made of bronze. The internal check and relief assemblies are modular and are made of plastic. The check and relief valve seats are replaceable. All springs are contained when the cover is removed. The relief valve had an external RV sensing line.

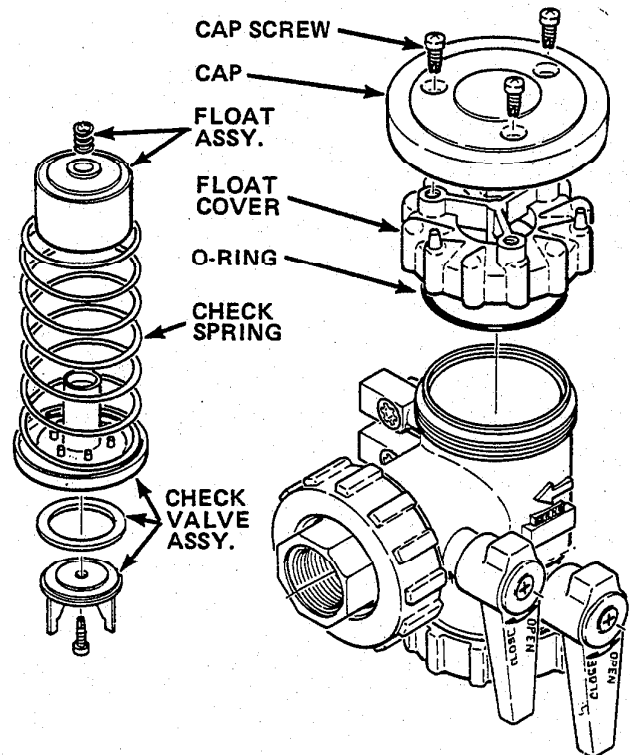
This is a pressure vacuum breaker assembly. Production began approximately 1977. It is a celcon plastic bodied unit with ball valve shut-offs built into the assemblies body. The check seat is cast in the body and is not replaceable. There is spring tension from the check spring when the bonnet is unscrewed. Internal hardware parts are mostly made of plastic. The original model designation was PVB, it later adopted the separate model number for each size.
